1775H - CR 119,651

Advanced Manufacturing Development of a Composite Empennage Component for L-1011 Aircraft

QUARTERLY TECHNICAL REPORT - NO. 13

This report is for the period 1 January 1979 through 31 March 1979

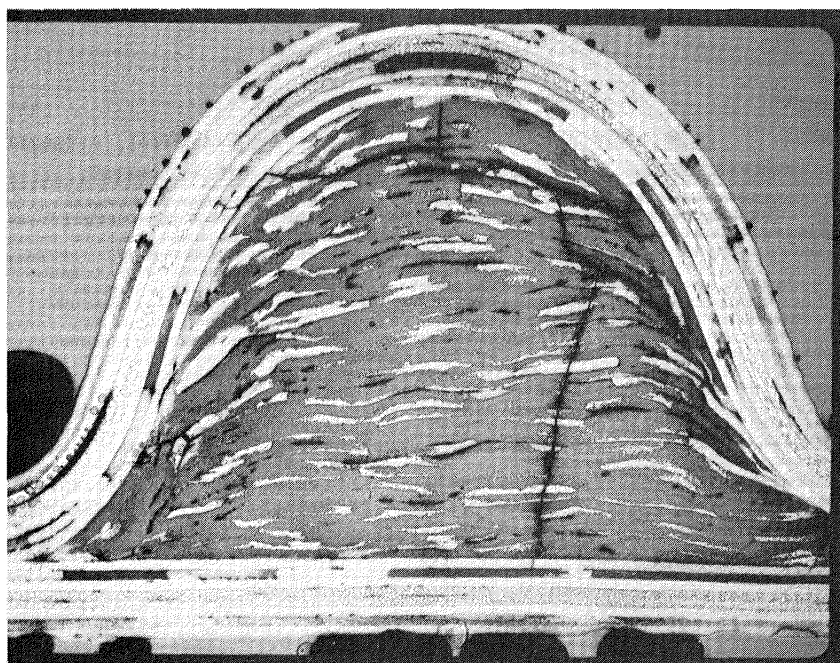
Rib development continued through January 1979 to focus on methods of making stiffening beads which were free of microcracks. The bead design upon which development effort had been concentrated is the "baseline" design which is a mass of all 0° fibers embedded centrally in the laminate. Various tooling and fabrication approaches were pursued in the attempt to provide a satisfactory bead. However, the best manufacturing effort, which is shown in Figure 3-3, still revealed cracking through the 0° fibers.

Figure 3-3. Microcracking Through 0 Degree Fibers in "Baseline" Stiffening Bead

Recognizing that the tendency toward cracking increased with the volume of 0° fibers in the bead, Engineering proposed alternate concepts for bead design. These concepts provided for moving some of the 0° fibers from the bead to the flange, and breaking up the amount of these fibers in any single grouping. See Design Concept "C" in Figure 3-1.

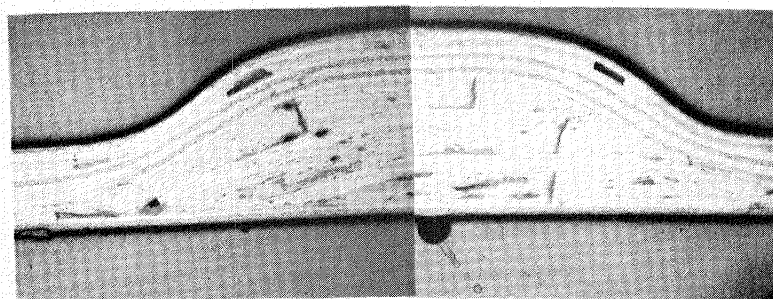
Figure 3-10. Microphotograph of Concept "D" Bead
Showing Cracks Through the 0° Plies

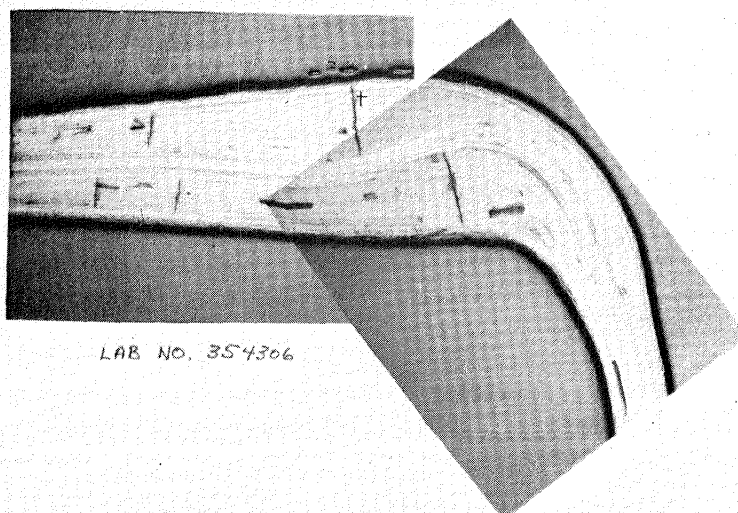
Figure 3-11. Microphotograph of Concept "D" Flange
Showing Cracks Through the 0° Plies

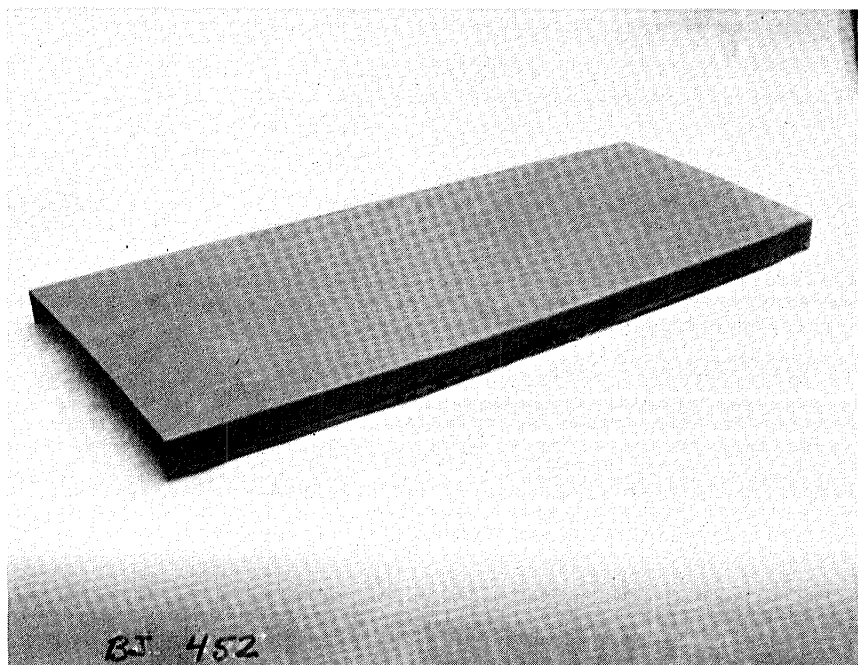
Two development parts were molded to this configuration. The first part is seen in Figure 3-18. Quality Assurance confirmed acceptable resin content, specific gravity, short beam shear, and compressive strength values. An ultrasonic scan detected voids in an area near the flanges next to the trailing edge. Microphotos validate the scan. These voids were caused by the silicone bag which did not fit over the part correctly.

Figure 3-18. Solid Web Rib Made with Syntactic Resin Core

Both parts exhibited some bow and twist after cure. Investigation into the cause and cure of this condition is in progress.

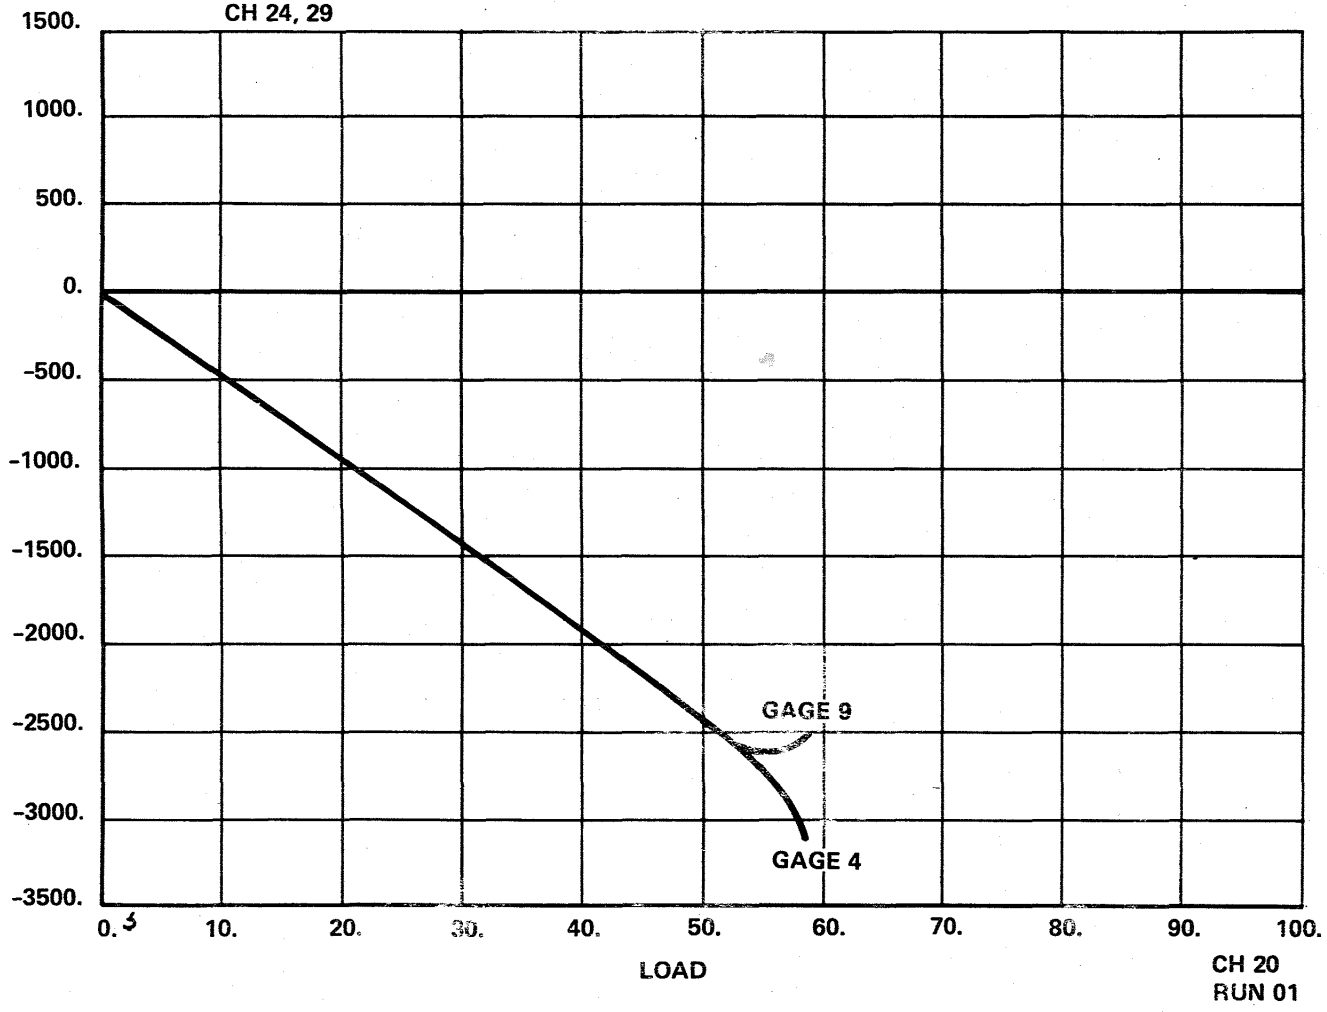
The test was conducted in two parts. First, the panel was loaded up to design ultimate compression load of 58,100 lbs with continuous data recordings. The panel load was reduced to 10,000 lbs and held while the recorded data was examined. The panel did show some initial buckling in the skin at 54,000 lbs load, as can be seen from Figure 4-5.

Figure 4-5. Strain Gages 4 and 9 - Limit Load Condition

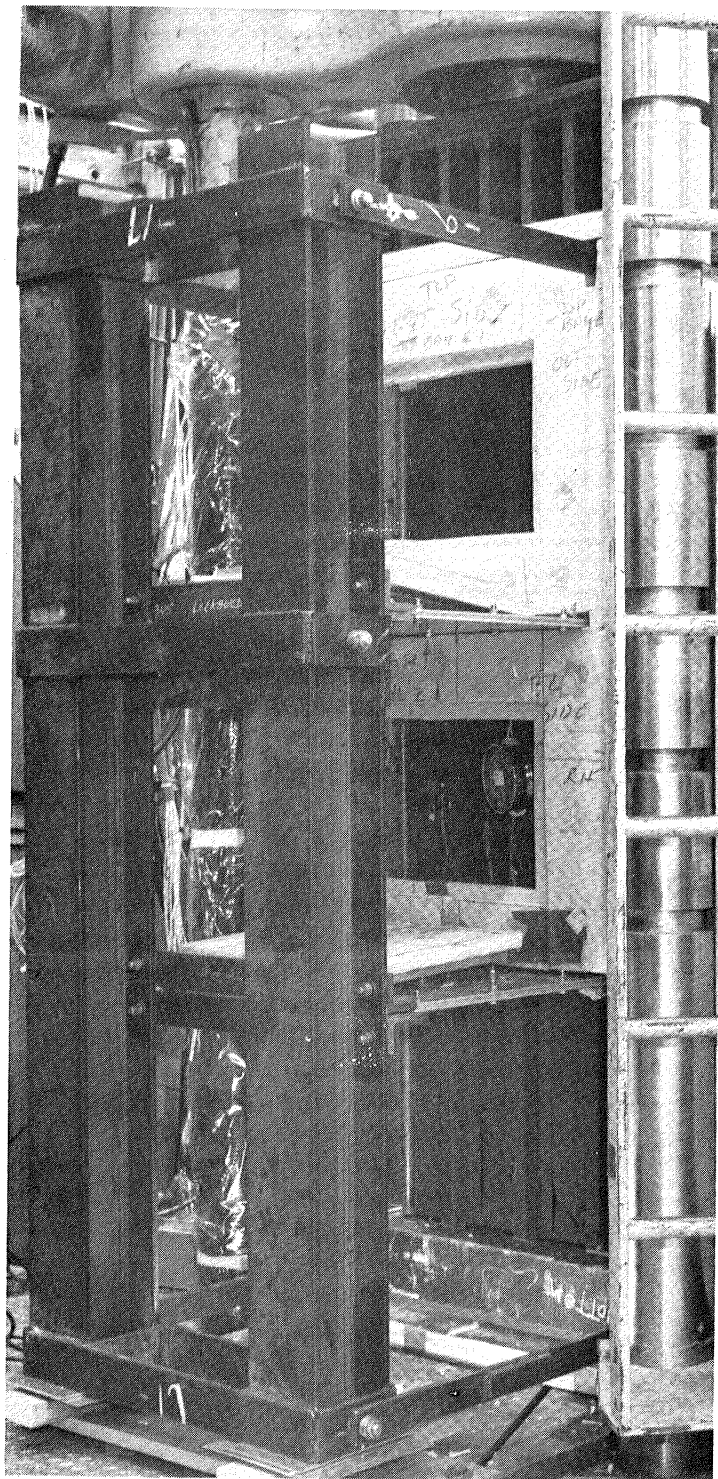
The second test objective was to run the panel continuously to failure with the data being continuously recorded during the test. Failure of the panel occurred at 70,000 lbs, 120% of ultimate load. Initial buckling was indicated in the back-to-back skin gages at about 54,000 lbs compression. Figures 4-6 and 4-7 show the buckling of the skin panels between the hats. The predicted failure loading was 80,000 lbs and predicted initial buckling was 48,000 lbs.

Failure occurred in the lower bay of the 3-bay panel. Examination of the panel indicated that a skin/hat separation had occurred with subsequent rapid failure of the hats and skins shown in Figures 4-8 and 4-9. The failure is considered to be fixture induced as the end potting introduces a bending moment due to the built in effect. The damaged area will be cut off and the specimen will be retested in a different configuration to find the true failure load.

Figure 4-8. Shows Failure in the Lower Bay Area

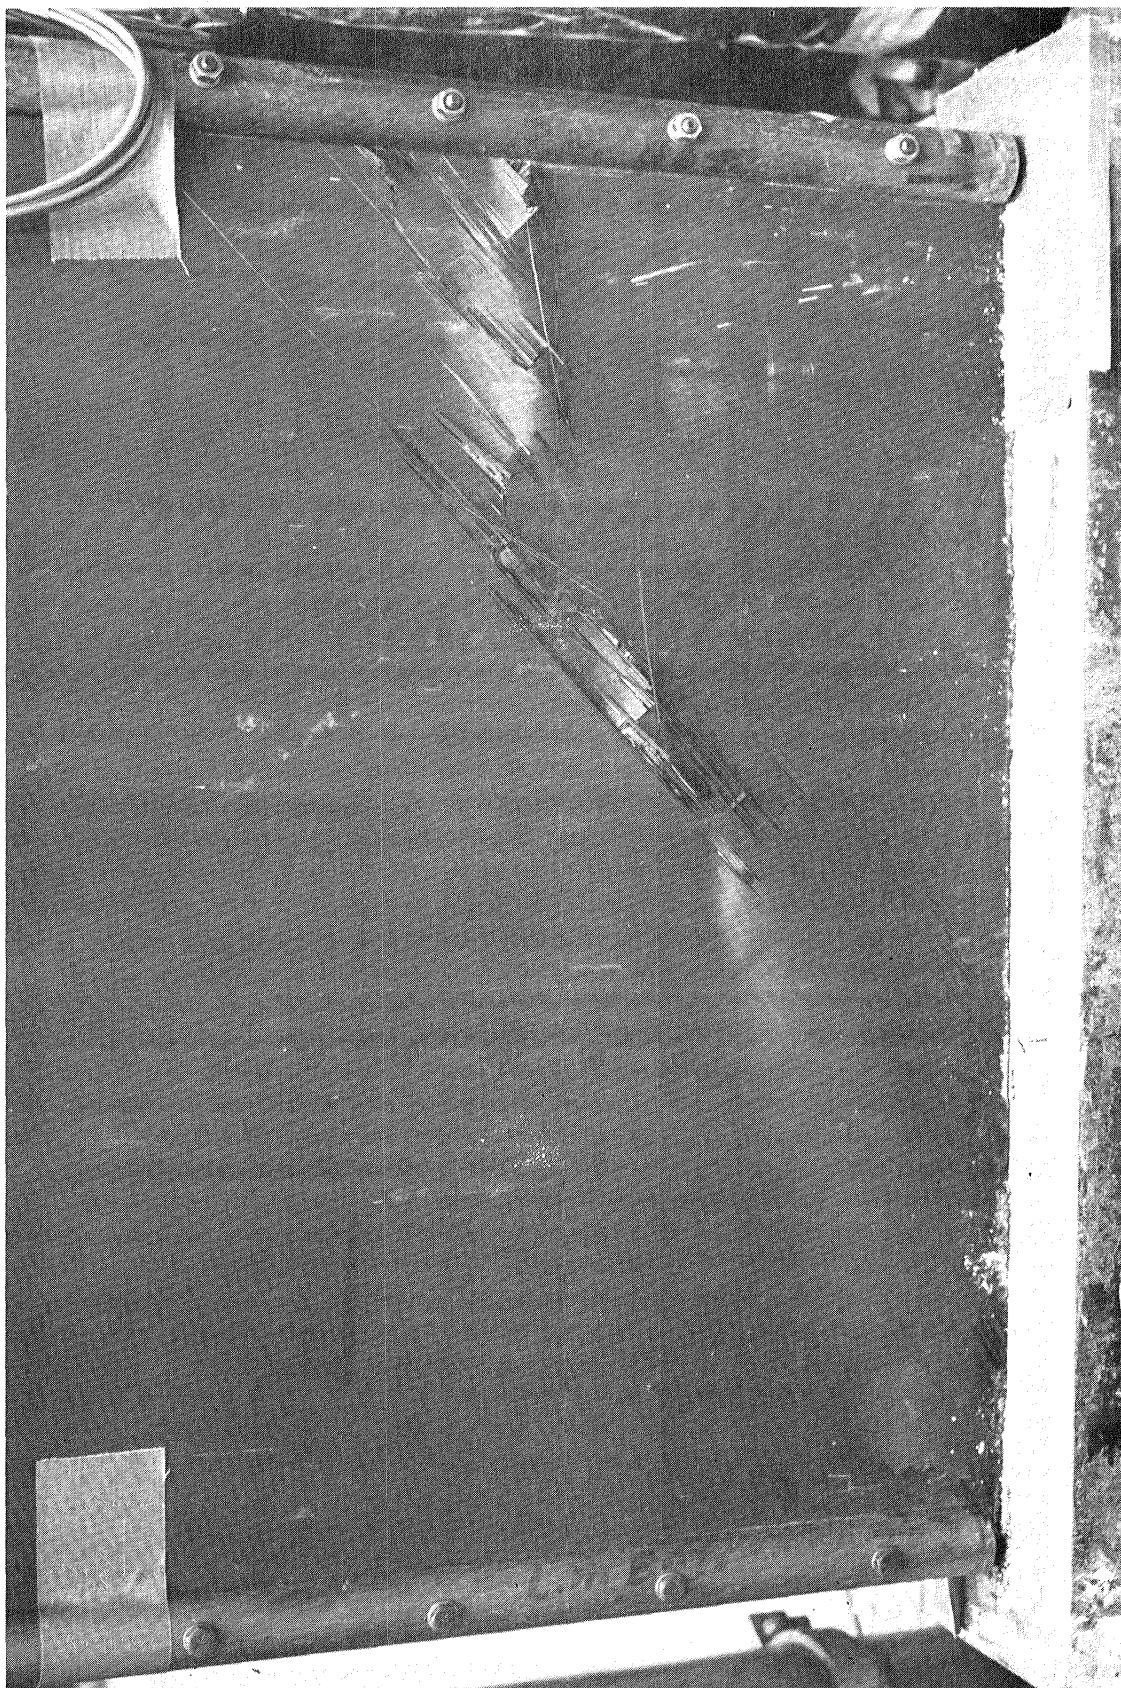
Figure 4-9. Closeup of Skin Side Failure

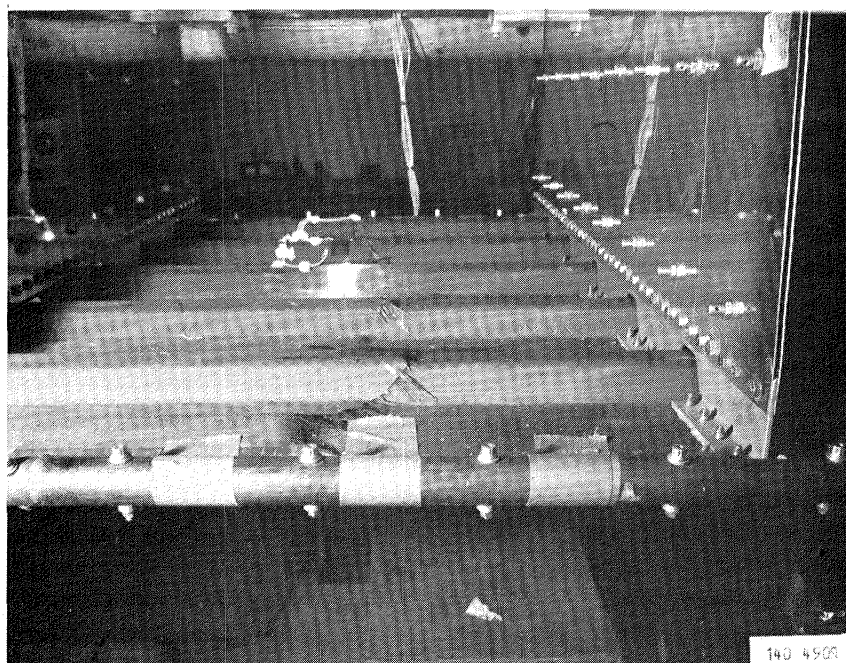
After completion of this sequence, the limit load cycles were again applied. Failure of the panel occurred at 96% of limit load in compression. Figures 4-16 and 4-17 show the panel after failure. The panel had carried 100% of limit load in tension and was in the limit load compression cycle at failure.

The test demonstrated that the cover can withstand one-half lifetime of fatigue loading and can carry limit load with obvious partial damage. The panel in fact sustained one-and-a-half lifetimes of fatigue and two applications of limit compression and three applications of limit tension. Failure in the compression mode was due to the high stress concentration at the end of the saw cut which was a tenth-inch wide. Local surface delaminations at these ends precipitated failure.

Figure 4-16. Stiffener Side After Failure

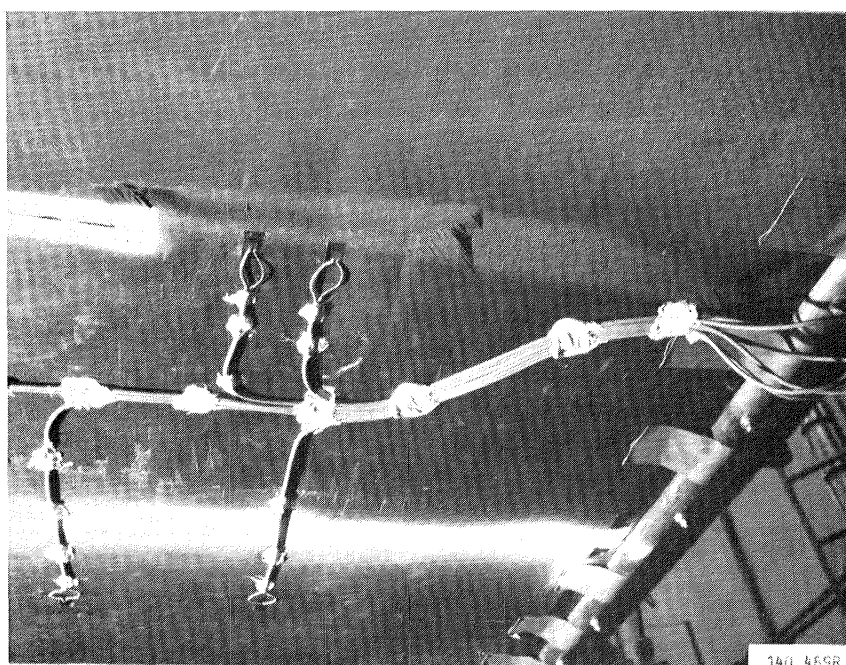
Figure 4-17. Skin Side After Failure

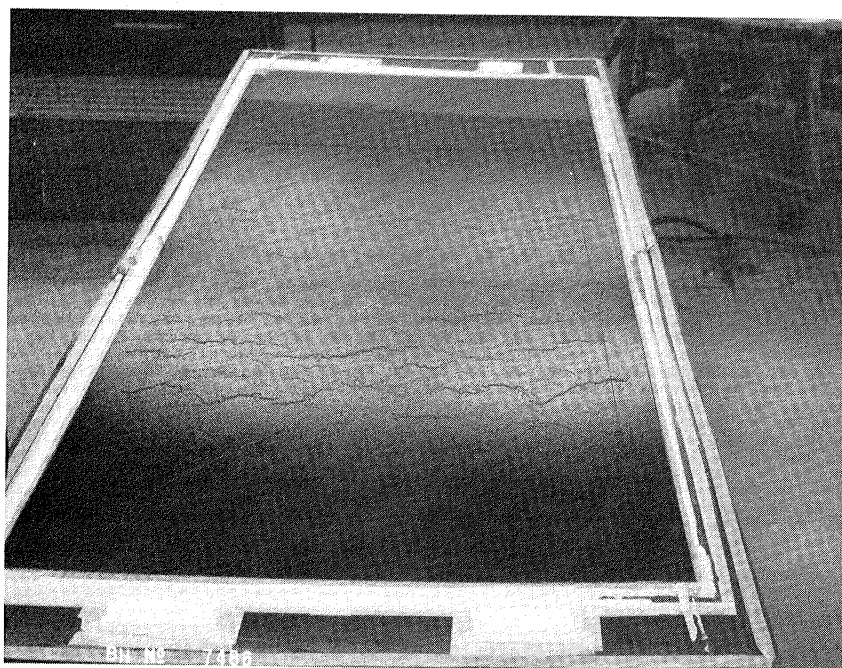
1. The wrinkles are being formed during the cool-down from the 225°F prebled temperature or subsequent to cool-down. There are no wrinkles while the part is above some critical temperature.
2. By physical appearance there are three kinds of wrinkles:
 - (a) Sharply defined straight-line wrinkles following fiber directions
 - (b) Irregularly shaped wrinkles lacking orientation
 - (c) Wrinkles following the contour of doubler sections or tapered sections

Figure 7-1. Typical Wrinkled Panel

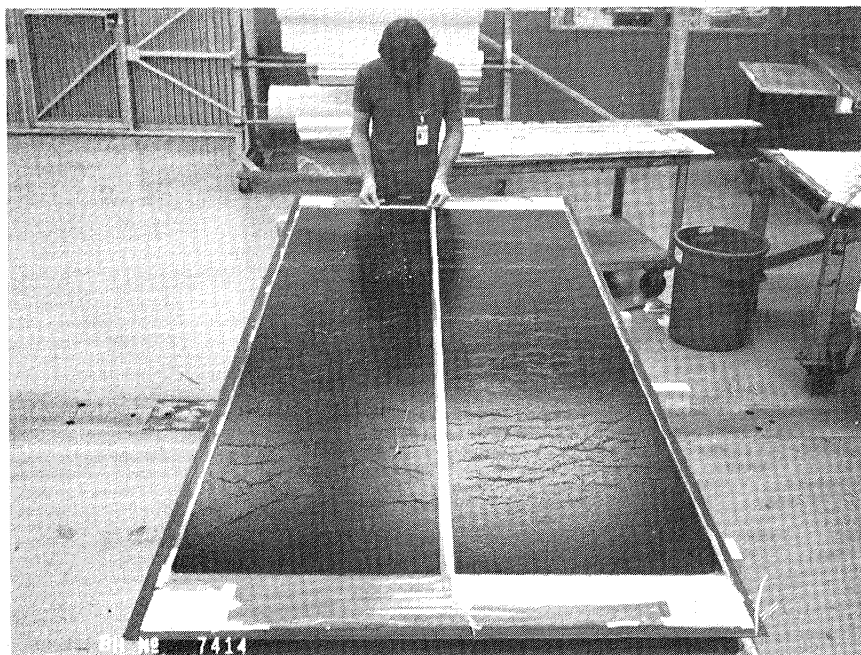
Since it was evident that all wrinkles were removed during final cure and that laminates containing 16 or more plies were essentially free of wrinkles the ancillary test cover specimens were fabricated using the single stage prebleed of the skin and hats prior to final curve. With these larger laminates, up to 80 ins. long and 16 or more plies thick some minor wrinkling was evident prior to final cure. All wrinkles disappeared during the final

Figure 7-3. Wrinkled Prebled Panels Prior to Combining and Curing

cure and no ill-effects were noted either in NDI or in the destructive testing. The components failed generally as predicted, at or close to the predicted loads.
